The column facades on the 13-story, 25-year old beachfront Villager Condominium in Melbourne Beach, Florida failed early on.

In 2012 Existing Structures Engineering, Inc. of Cape Canaveral, FL engineered the rebuild and restoration of the columns per ASTM C-926, specifying **Ultra-Lath** plastic lath attached with corrosion-resistant fasteners.

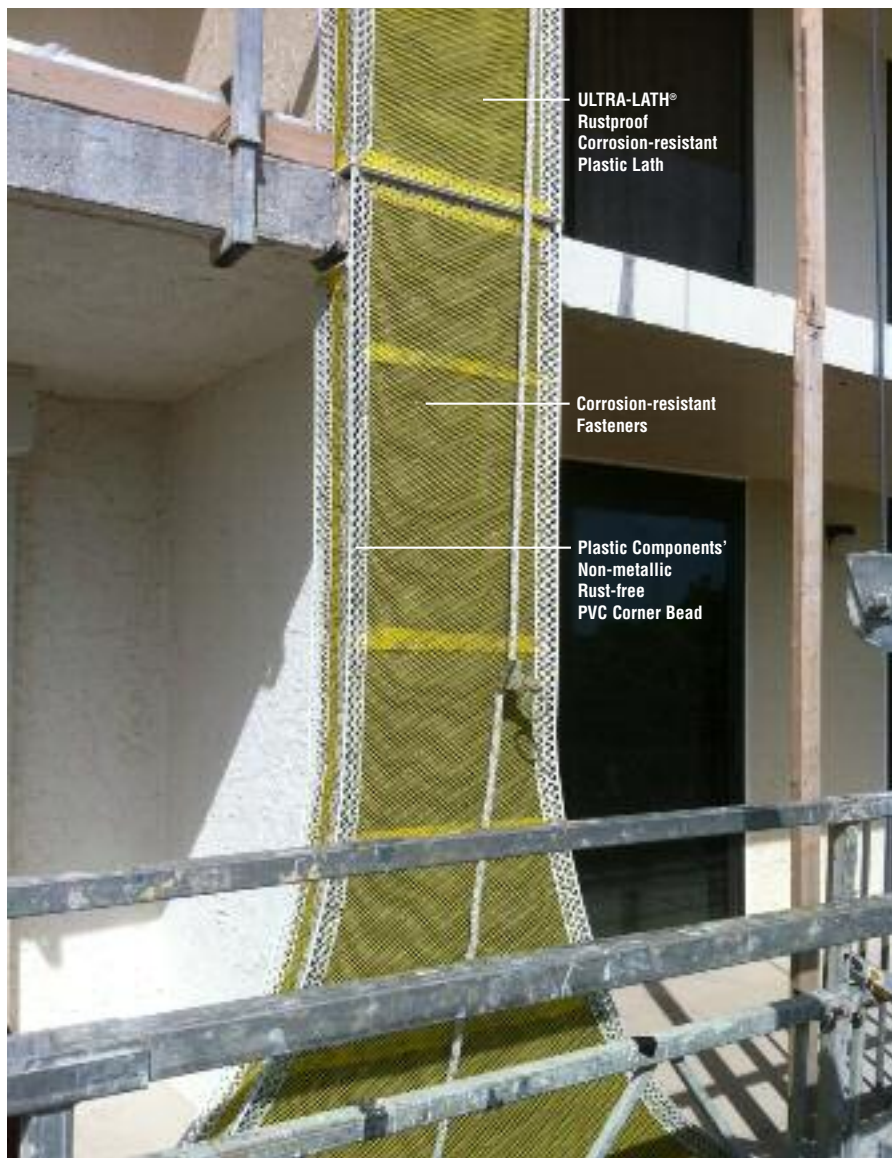
Exposure to coastal environmental conditions on the eight 130 ft columns surrounding the building caused corrosion of the lath and fasteners within the stucco, creating a constant source of aesthetic degradation and repair expense to the condo association.

The columns are now corrosion-free and should remain that way for the life of the structure – *thanks to Existing Structures Engineering and Plastic Components' Ultra-Lath.*
